Testing and Characterization of Service Exposed P22 Welded Steel

S. E. Eren^{1,a}, A. Tonti^{2,b}, B. Petrovski¹, V. Ventzke¹ and M. Koçak^{3,c}

¹ GKSS Research Centre, Max-Planck-Str. 1, 21502 Geesthacht, Germany

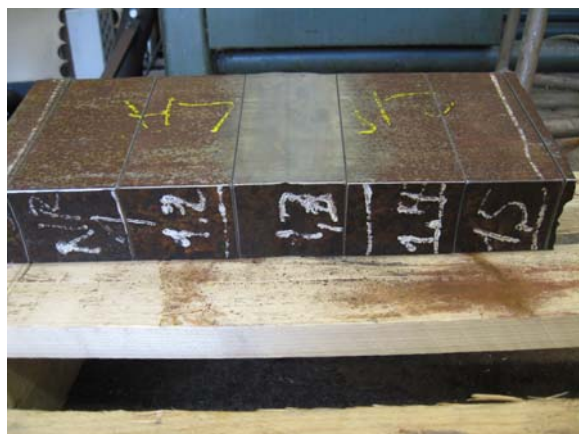
Figure 1 b. As-received outlet header used for the characterization of service exposed 145 mm thick base material with butt joint.

The as-received materials, outlet header designed as SH2, was sectioned for the characterization of both butt joint and the nozzle fillet weld with connection pipe to same purpose header. 700 mm long SH2 outlet header (Figure 1) possessing a diameter of 665 mm was further cut into four pieces for the manufacturing of specimens (Figure 2). Additionally, in Figures 3-5 one can see the exact locations of the specimens.

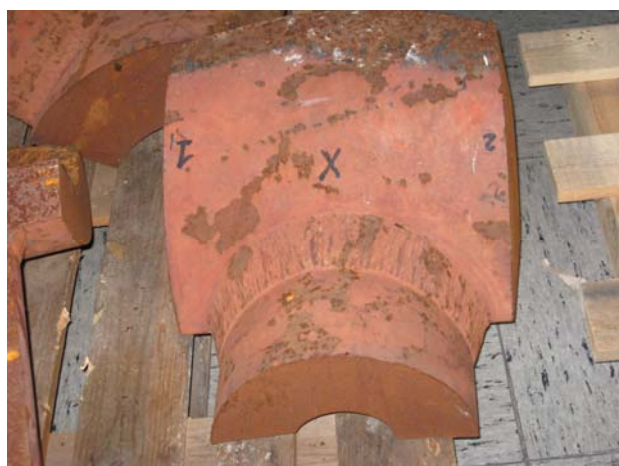
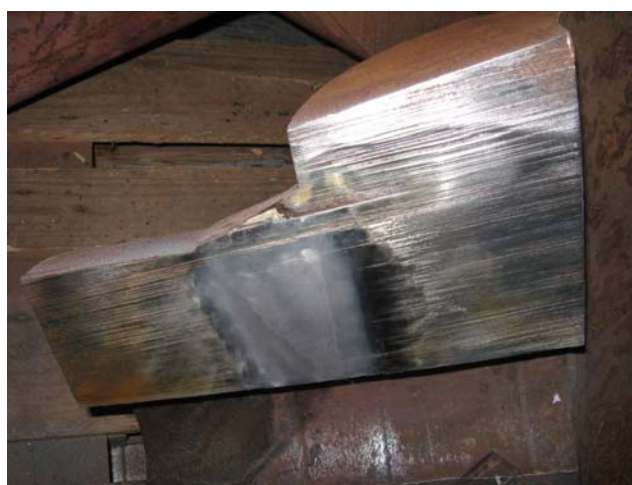
Figure 2. As-received nozzle sections (100 mm thickness welded to 150 mm thick material) after cutted into two pieces and etched for identification of weld area.

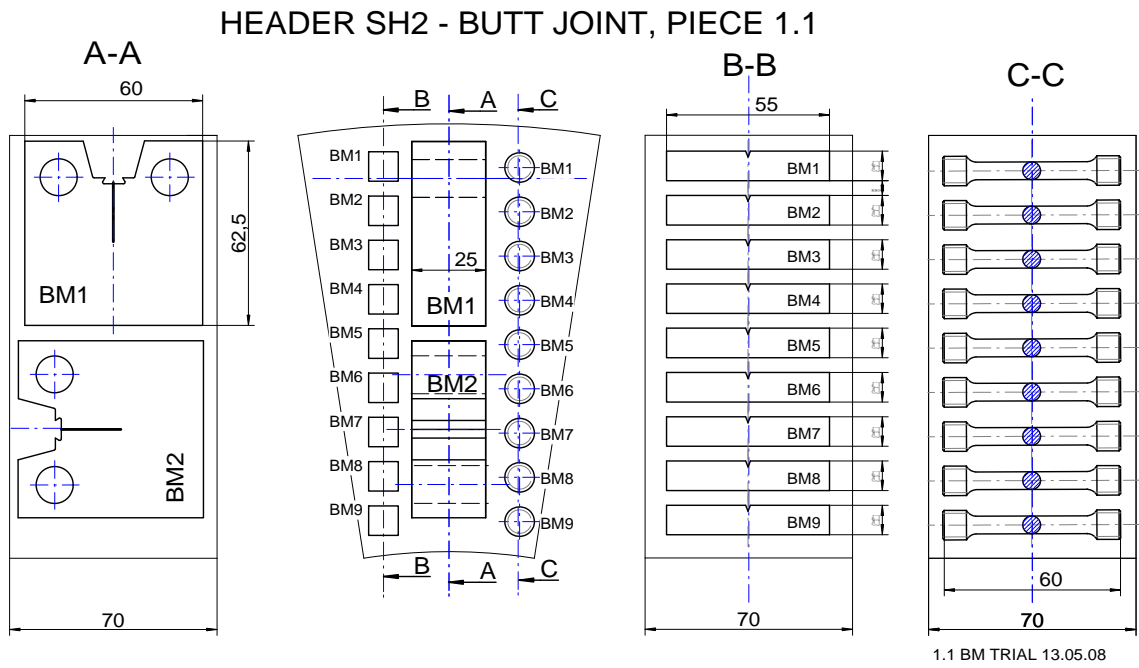
Figure 3. Partial cutting plan of Base Material

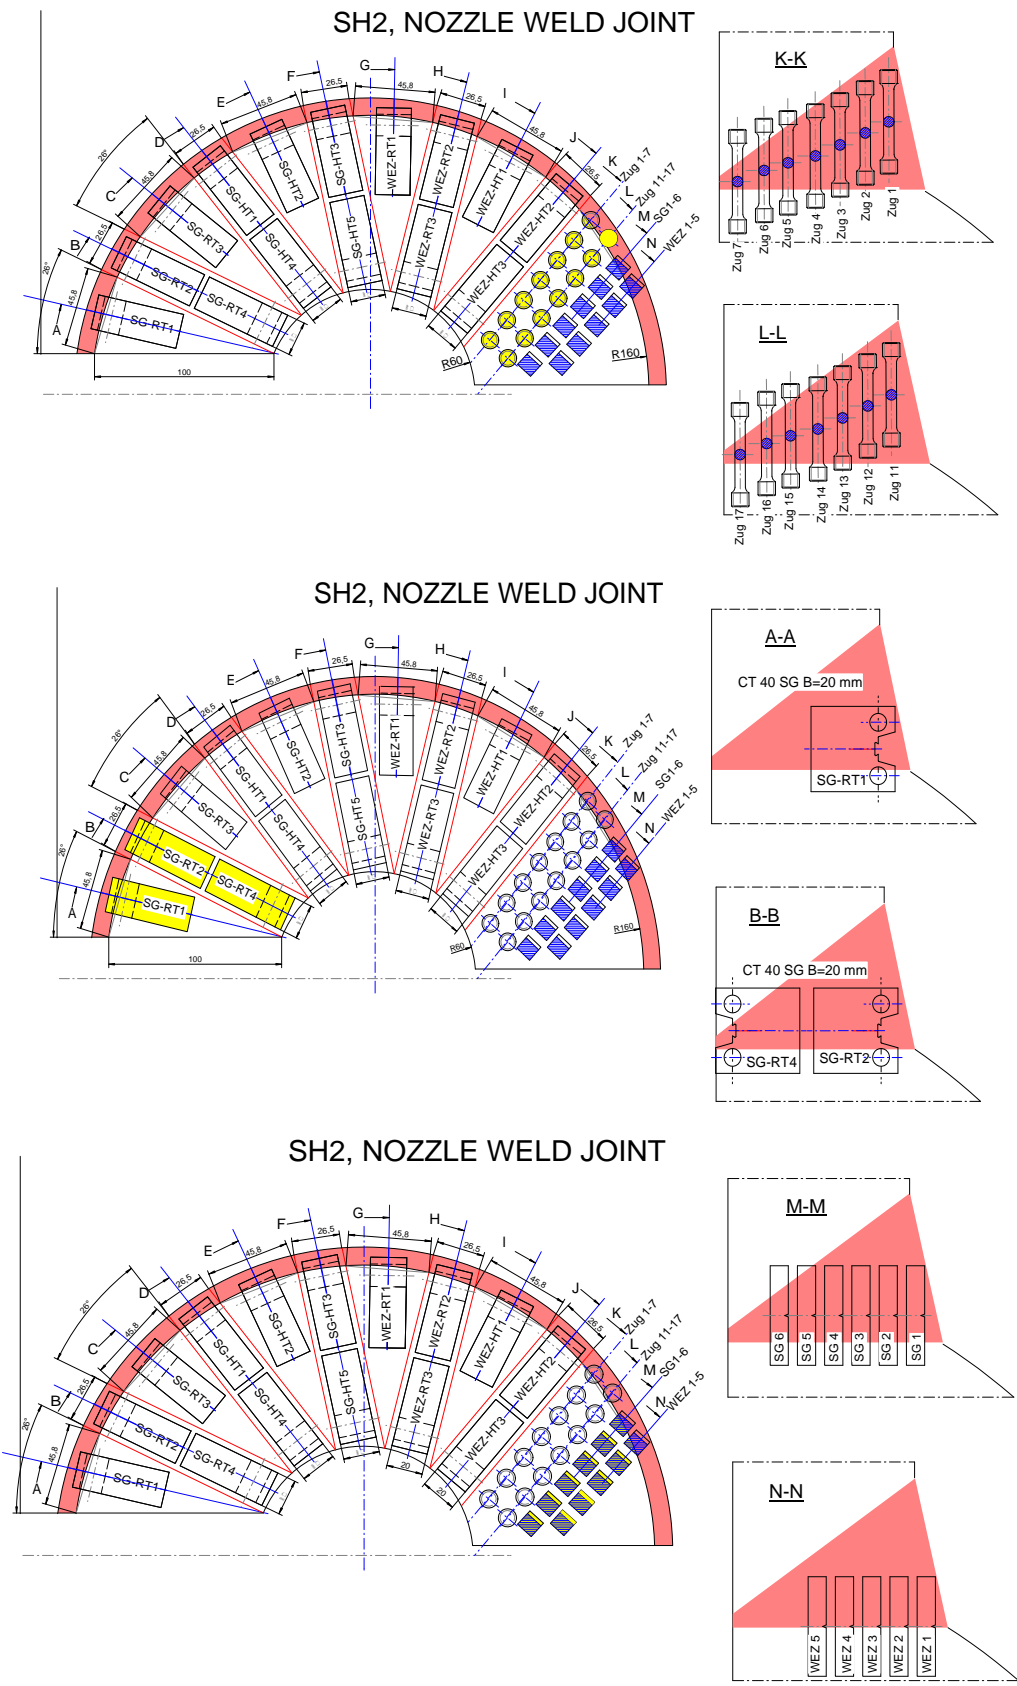
Figure 5. Partial cutting plan of Fillet Weld of Nozzle

Tensile properties of the weld material were obtained from testing of round tensile specimens both at RT and 540°C (see Figure 5 for the description and location of the specimens tested).

Although the average yield strength of the joint at RT is calculated as 325 MPa and the ultimate tensile strength as 461 MPa, these values should be used with precaution. Since as can be seen Figure 5, the specimens include

different portions of weld material (see Zug 1 – Zug 7 in Figure 5). While only specimens designated as “Zug 1” and “Zug 2” are all weld metal specimens, the other specimens include decreasing percentage of weld material and that enables testing of the joint itself including base material, weld material and also heat affected zone (HAZ). However, the average values obtained from these two specimens were found to be 292 MPa and 443 MPa for yield strength and the tensile strength of the weld material.

At 540°C, from “Zug 11” and “Zug 12” all weld metal specimens, yield strength value was obtained as 220 MPa and the tensile strength as 230 MPa, lower than the room temperature values, as expected.

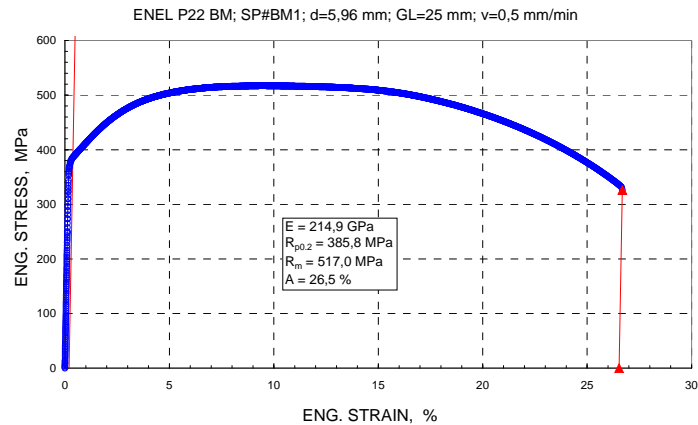
Figure 6. Typical stress-strain curve of the service exposed (110.000 hrs/540°C) P22 steel

The plate thickness of butt joint was 145 mm, while nozzle materials were 100 mm and 155 mm thick. Tensile properties of the P22 base material were obtained from testing of round all-weld metal tensile specimens, with a gauge length of 25 mm. The average yield strengths of the BM extracted from two different bulk material locations were found to be 300 and 362 MPa respectively. The average tensile strengths of the same pieces were obtained as 490 MPa and 521 MPa for both material pieces with elongation values of 31% and 28%. In Figure 6, a typical stress-strain curve of P22 steel exhibiting continuous yielding behaviour can also be seen.

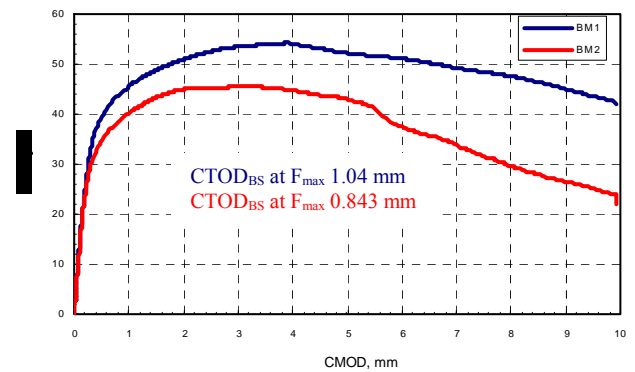
Figure 7. Load vs. CMOD diagrams of the two CTOD fracture toughness C(T) 50 specimens of the base material tested at Room Temperature

CTOD fracture toughness obtained from C(T)50 specimens in accordance with the British Standard BS 7448 were found to be ranging from 0.714 mm to 1.031 mm at RT and from 0.240 mm to 0.394 mm at 540°C. During Room Temperature tests, some specimens have shown ductile fracture type of failure, as Load vs. CMOD diagrams of the BM and WM shown in Figure 7. Therefore, CTOD values of the maximum load attained were calculated for such specimens. Where unstable fracture occurred such as in BM specimen obtained from outlet Header SH2 the CTOD value of failure point was taken.

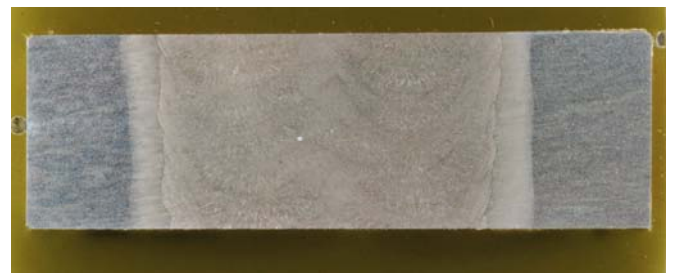
Figure 8. Macrograph of service exposed P22 butt joint – middle

Figure 8 shows the middle of the weld joint which was originally 145 mm thick. The hardness measurements has already indicated slightly undermatching (lower yield strength level in the weld metal compared to the base metal) behaviour, average of measurements being 160 HV in the Base Material and 150 HV in the Weld Material.

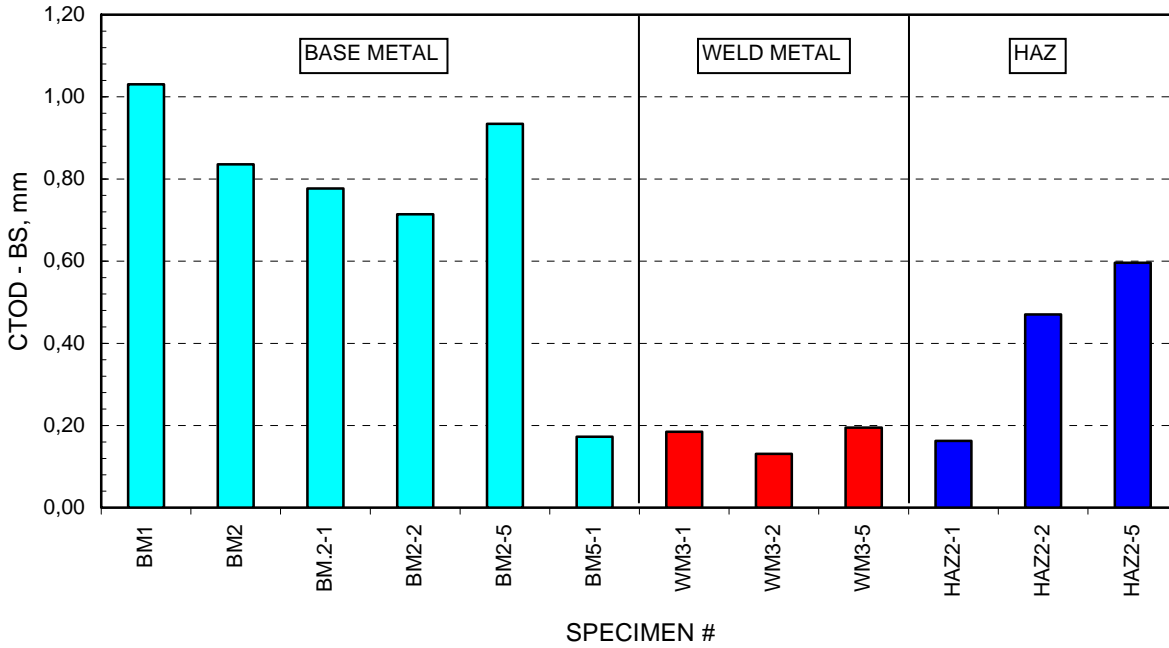
Figure 9. Fracture toughness of P22 Base Material, Weld Material and Heat-Affected-Zone at RT

The fracture toughness results given in Figures 9 and 10 are showing clearly that weld metal and partly HAZ are having lowest fracture toughness values compared to the base material. Similar results were obtained from Charpy-V tests. The Charpy-V specimen results have shown some variation for the Weld Material (20.3 J being the minimum value and 87.1 J being the maximum value) and for Heat-Affected Zone (22 J being the minimum value and 95.6 J

Apparently, the weld material has gone most degradation process during service exposure and exhibits very low RT fracture toughness properties. When the tests conducted using standard C(T)50 specimens at 540°C, both values of BM compared to RT have shown lower values, whereas WM specimens exhibit higher values than the RT values.

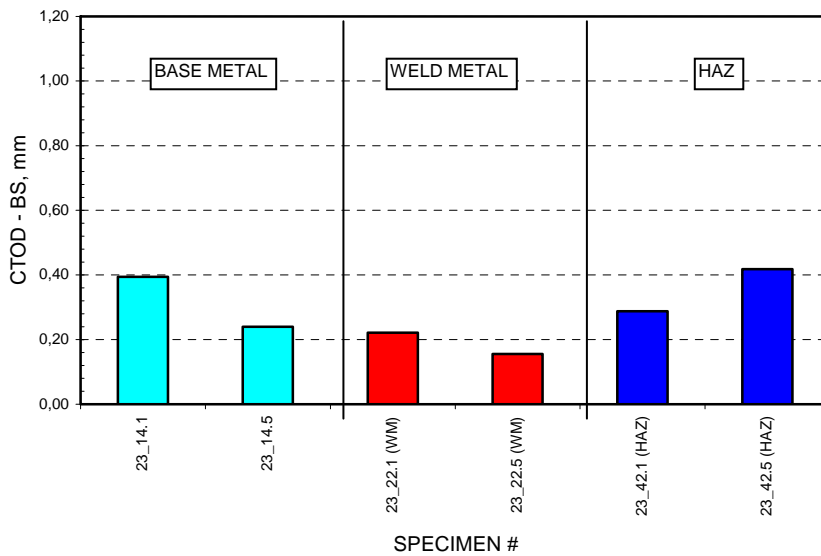
Figure 10. Fracture toughness of P22 Base Material, Weld Material and Heat-Affected-Zone at 540°C
